IF YOU DON'T UNDERSTAND MOLD REMEDIATION, GET OUT OF THE INDUSTRY!

This article was published as a three-part series in the February, March, and April 2009 issues of *Cleaning and Restoration* magazine.

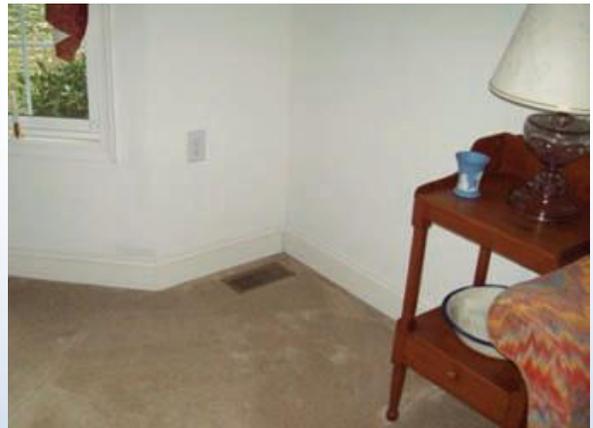
In units where carpeting had gotten wet along outside walls, the environmental company issuing the scope of work told the remediation contractor that removal of two feet of carpet along the wall was required. Since the units were seven years old, matching the carpet would have been nearly impossible, meaning that all carpeting in any damaged room would have to be replaced.

As a practical example of the dilemma that this policy posed the contractor cited a recent job that required removal of about nine square feet of carpet in the corner of a living room. If this small piece was removed in order to meet the two-foot mandate the carpet on the entire first floor would have to be replaced since the floor plan was wide open with a continuous run of carpet.

Photo 1: This corner of the living room was part of a mold remediation project caused by water infiltration through the exterior stucco and stone. Although little damage is visible, the need for remediation of fungal contamination in the wall cavity was verified during the exterior demolition of the leaking siding. Notice the supply register in the floor. Debris and discoloration around the register initially led the hygienist to require the removal of two feet of carpet along the wall.

Explaining to the contractor this distinction and assessment of the different areas and materials is crucial. If the carpet has substantial fungal growth visible then it should be classified as Condition 3. In such cases, removing the impacted areas of carpet and an appropriate boundary area, such as a two-foot swath, is appropriate. If that results in total carpet removal, then so be it. However, if the carpet is in proximity to the impacted wallboard but is not showing mold or mushroom growth, it should be assessed as Condition 2. Condition 2 materials, even porous materials, can be cleaned. To support this I encouraged the contractor to direct the hygienist to section 14.3.4.1 of the S520 on pages 55 & 56 entitled “Cleaning Porous Contents” for confirmation and specific guidance.

I went on to commend the contractor on his training and common sense – which were right on the money. If the carpet is near wallboard with fungal growth but does not show visible mold, a hygienist should either sample it to determine if it is impacted or assess it as Condition 2. If there is no visible growth on the carpet, even on the back side when it is released to get it out of the way of the remediation of the gypsum board, then it can and should be saved.

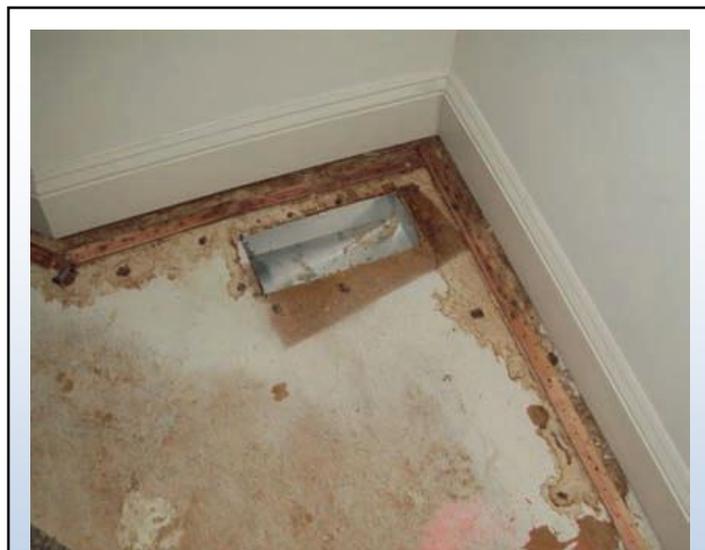
Photo 2: Staining on the subfloor in the area shown in photo 1 clearly indicates that the water infiltration was coming from the wall cavity. There was no discoloration around the supply vent that would indicate that the discoloration on top of the carpet was mold growth from water on all sides of the register.

During this discussion the contractor was able to educate the hygienist and even offered an explanation for his confusion. He pointed out that a floor-mounted supply vent was located in the living room remediation area directly on top of the carpet (see photos). Because of the age of the homes the contractor speculated that the hygienist was reacting to a visual inspection in which he

saw the black/dark residue that accumulates at supply registers over time if ductwork is not clean. In such situations, the carpet fibers act as a collection device for debris from the HVAC system and the general air in the house. When that condition occurs in an area close to water damage it is easy to mistake the discoloration for mold growth.

If it is determined that the carpet qualifies as Condition 2 rather than Condition 3, the most appropriate restoration technique would be to conduct a thorough HEPA vacuuming of the carpet prior to the remediation work. Then it should be released and moved out of the way during the isolation and remediation of the damaged drywall. During the remediation process the carpet pad should be cut, disposed of, and replaced just to make sure that it is not a continuing source of bacterial or fungal contamination. This process would allow the contractor to observe, clean, and, if necessary, seal the subfloor.

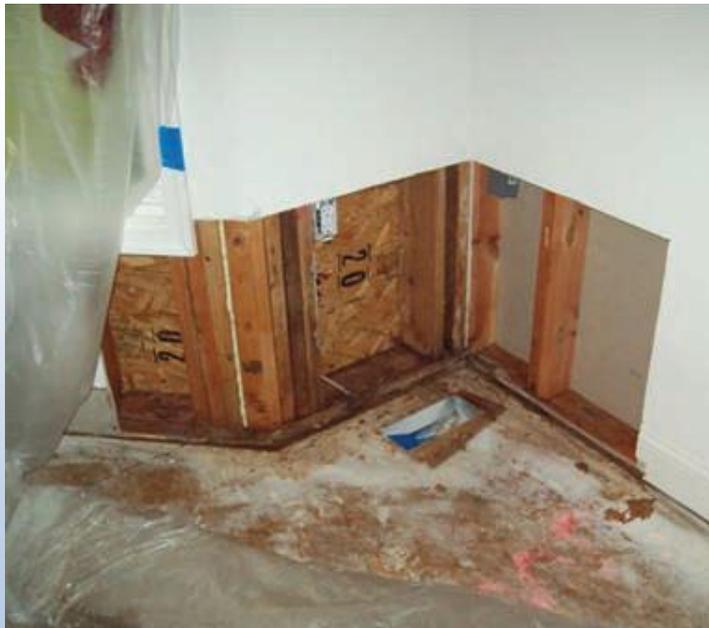
Photo 3: Removal of the mold impacted drywall revealed the new sheathing board that had been installed during the exterior portion of the remediation project. Removing the blown-in and cellulose insulation from the outside and later replacing it with foam board insulation substantially reduced the amount of mess and cleaning that was necessary during the interior phase of the remediation.
