Sometimes Mold Remediation Is Really Complicated

Proper Source Removal at an Active Air Traffic Control Tower

Michael A. Pinto, CSP, SMS, CMP, CFO

Wonder Makers Environmental

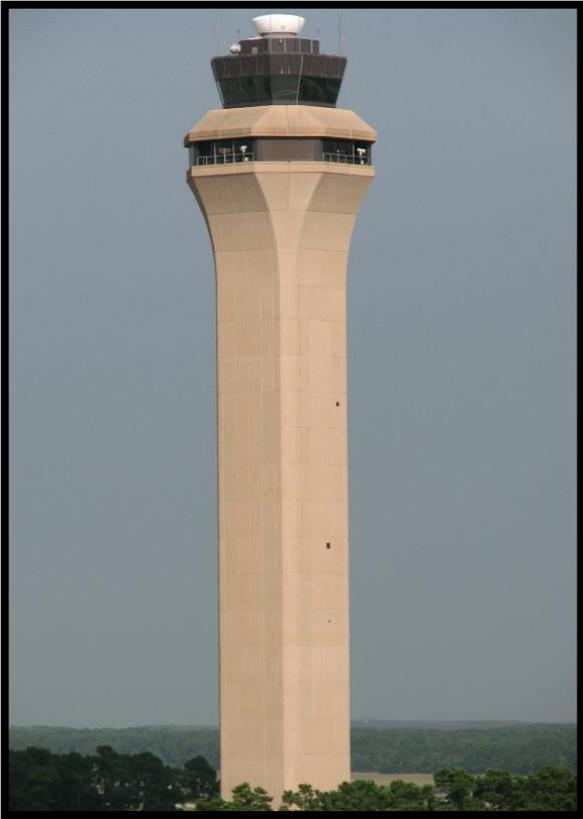
ILLUSTRATION 1

Photo of a typical Air Traffic Control Tower (ATCT) found at larger airports across the US. Most of the windowless square tower is designed to be unoccupied. Radar equipment is on the roof and in the rooms where the tower flairs outward. The air traffic controllers work in the glassed-in section at the top of the tower called the "CAB."

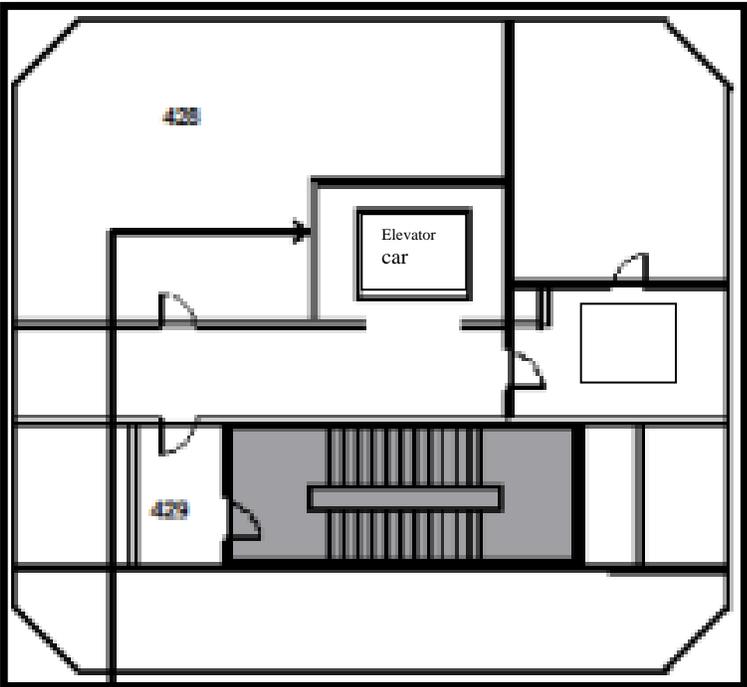
ILLUSTRATION 2

The lower section of the tower is uniform in layout with an elevator shaft in the center, emergency stairwell, and equipment rooms on either side of the elevator.

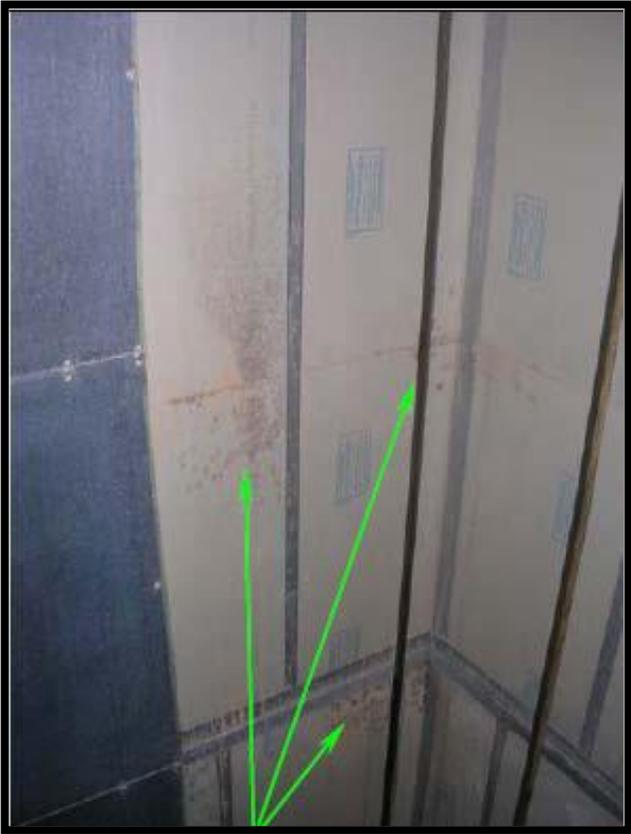
ILLUSTRATION 3

The elevator shaft and finished walls on the exterior of the tower had suffered from water intrusion for years. As a result, mold growth was extensive on all the different layers of the material that made up the walls of the elevator shaft and on the back side of the double-layered gypsum boards which served as fire-rated walls along the exterior of the tower. The arrows indicate significant colonies of fungal growth.

Major water intrusion points included a poorly detailed flashing at the level just below the cab that allowed rainwater and snowmelt to enter and then move down, following the shape of the structure. The inspectors documented a situation where water from some of these leaks managed to travel

seven floors down. Another entry point for water was identified as the joints between the exterior concrete panels. Roof problems were contributing to the interior moisture along with plumbing leaks from roof drains in unmonitored areas and also allowed water to regularly enter the building. The HVAC system was likewise contributing to moisture problems, as extensive duct leakage (up to 40% on one section of the building) allowed conditioned air to cool surfaces above the ceiling tiles and creating condensation spots that supported fungal growth. Appropriate fixes for all of these issues were laid out by the team members so that once the mold remediation was completed, there would be no moisture sources inside the structure to fuel its return.

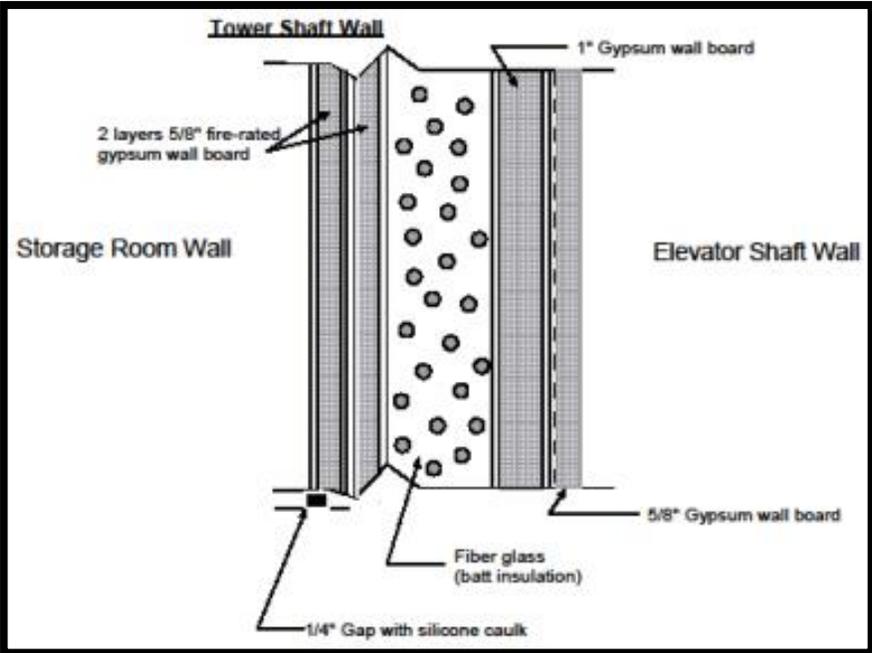
ILLUSTRATION 4

Construction of the elevator shaft involved multiple layers of material, all of which have been water-damaged and were supporting mold growth.
